SNOW CREEP INVESTIGATIONS NEAR THE SNETTISHAM TRANSMISSION LINE 609-76

IN SOUTHEAST ALASKA NEAR JUNEAU

Robert L. Meyer <sup>1/</sup>

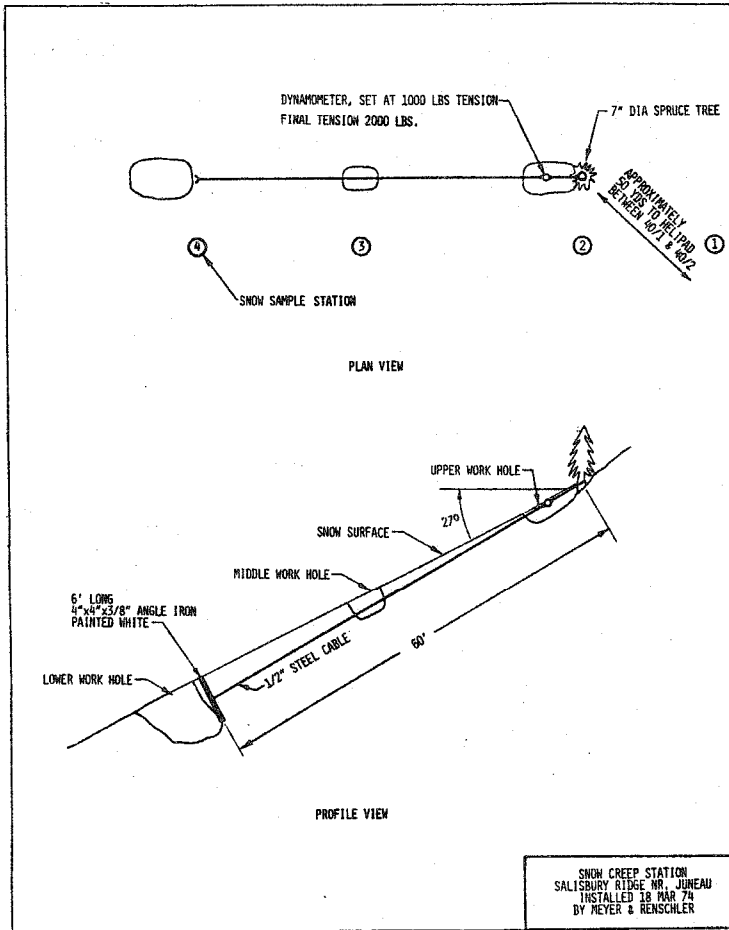
The snow creep system installed in 1974 was designed primarily to determine the size dynamometer required for use in snow creep systems planned for installation the following year. It was assumed that the disturbance to the snow pack caused by installation of this initial system could introduce significant errors into the results, and that use of the data for design criteria would be risky. The following plan and profile illustrate the design of the snow creep system installed on 17 and 18 March 1974.

The snow creep system consisted of a 4-inch x 4-inch x 3/8 inch (10.2 cm x 10.2 cm x 0.95 cm) steel angle 6 feet (1.8 m) long embedded into the snow at approximately right angles to the slope of the hill, which at that point was 27°. A 1/2-inch (1.3 cm) steel cable attached the angle iron to the dynamometer which was in turn anchored to a spruce tree of approximately 7 inches (18 cm) diameter. The cable was run through a hole cut into the snow using the Federal snow sampler. The total length of cable, dynamometer, and turnbuckle was 60 feet (18.3 m). The angle iron was painted white to reduce the absorption of radiant energy.

After the snow creep unit was in place, the lower and middle work holes were filled and packed with snow in an effort to reduce the effect of disturbing the snow pack in the test area. Finally, the tension was adjusted up to 1,500 pounds (680 kg) by means of a turnbuckle and then backed off to 1,000 pounds (454 kg) tension.

Snow samples were taken in the vicinity of the system, and the depth ranged from 67 inches (170 cm) above the anchor tree to 130 inches (330 cm) at the middle work hole. We were unable to reach the bottom of the snow pack adjacent to the snow creep angle iron because of frozen snow in the sample tube. The depth was in excess of 104 inches (264 cm) at that point. The measured densities ranged from 48 percent to 52 percent, and there was extreme difficulty in sampling both because of ice layers in the snow and due to snow sticking to the snow sample tube.

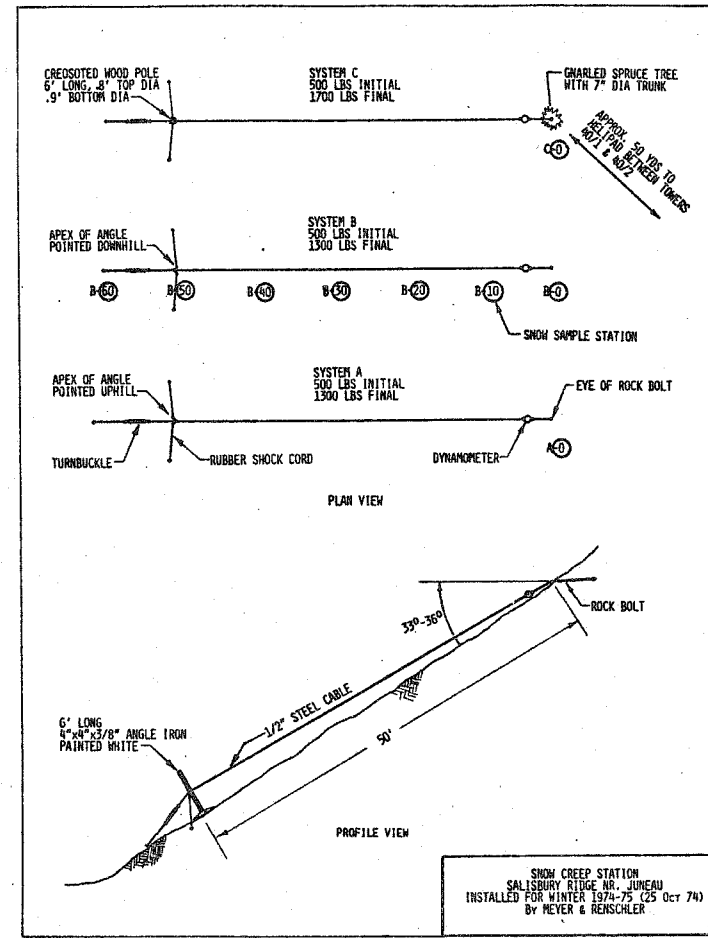
System A - 6-foot (1.8 m) long 4-inch x 4-inch x 3/8 inch (10.2 cm x 10.2 cm x 0.95 cm) steel angle oriented with the long axis at right angles to the slope of the hill and the apex of the 90° angle pointed uphill. The angle iron was painted white to reduce absorption of radiant energy.

System B - Similar to System A except the apex of the 90° angle was pointed downhill.

System C - 6-foot (1.8 m) long creosoted wood pole with a top diameter of 0.8 foot (24.4 cm) and bottom diameter of 0.9 foot (27.4 cm). The long axis of the pole was oriented at right angles to the slope of the hill. The wood pole was creosote colored. Both of the angle iron pieces and the wood pole were resting on a loose rock surface and were guyed with robber shock cord to keep them upright until the snowpack surrounded them. One-half-inch (1.3 cm) steel guy cable was used to interconnect the dynamometers, anchor bolts, and snow creep members. All systems were pretensioned to 500 pounds (227 kg) by means of turnbuckles to remove slack from the cables.

The following plan and profile shows the arrangement of the systems used in the winter of 1974-1975.

All three snow creep units had essentially the same length of guy cable connecting them to their anchor points. They were located in the same snow drift area; however, during the March snow sampling trip, it was observed that the wood pole member was near the edge of the high density wind-packed snow. The hillside on which the snow creep members were located was reasonably uniform in respect to slope and vegetation cover. There was a scrub spruce tree and rock outcrop located uphill from the creosote-treated wood pole which may have altered the snow creep characteristics for that system.
